EARTHQUAKES AND BUILDING CONSTRUCTION

A Review of
Authoritative Engineering Data
and Records of
Experience

Published by CLAY PRODUCTS INSTITUTE OF CALIFORNIA
611 Architects Bldg., Los Angeles 116 Natoma Street, San Francisco

COPYRIGHT 1929 BY CLAY PRODUCTS INSTITUTE OF CALIFORNIA

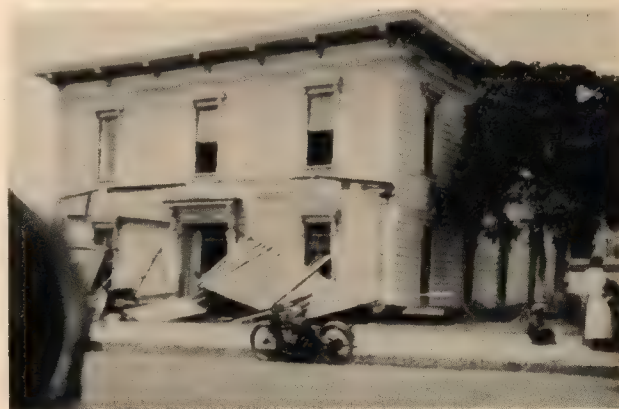
No. 76—Poorly built frame buildings suffered as did other improper construction. A wrecked frame dwelling.

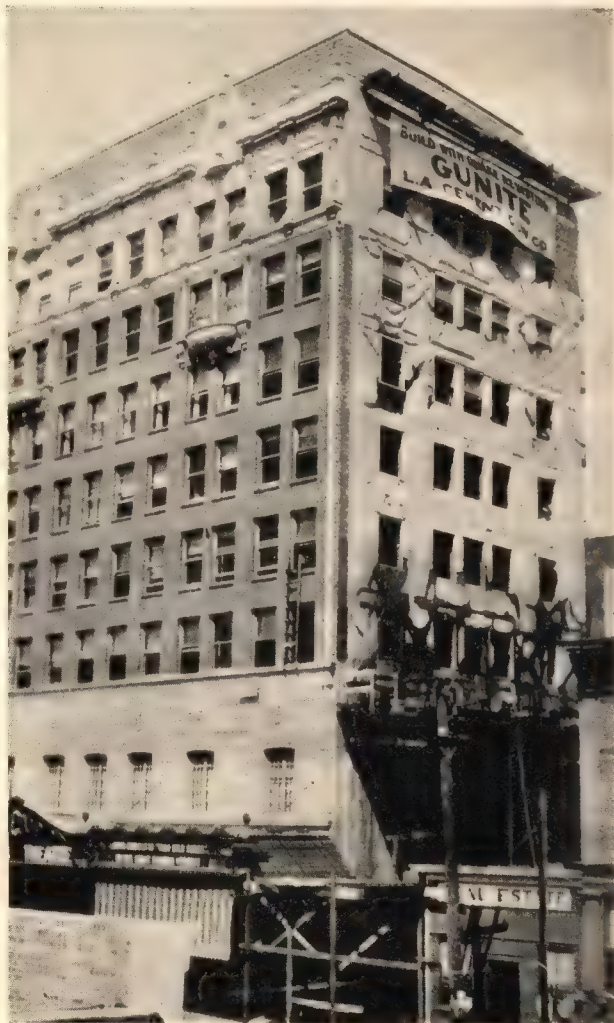
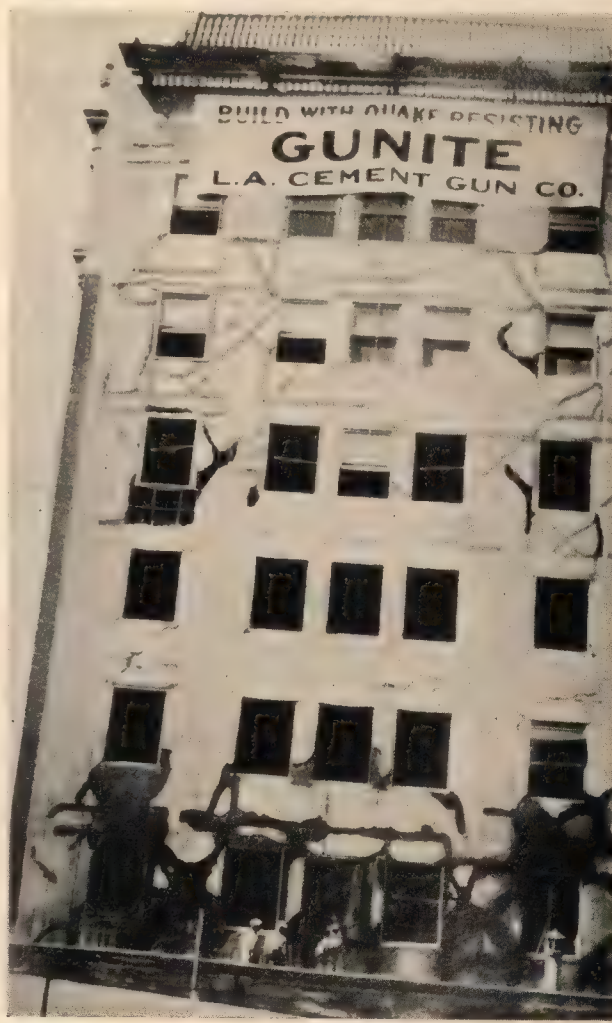
Nos. 80 and 81—Granada Theatre office building. Reinforced concrete frame, concrete filler walls. Photograph during repairs showing that columns were shattered.
